U.S. Copper Porphyry Mines Report

THE TRACK RECORD OF WATER
QUALITY IMPACTS RESULTING FROM
PIPELINE SPILLS, TAILINGS FAILURES
AND WATER COLLECTION AND
TREATMENT FAILURES.

JULY 2012

EARTHWORKS, July 2012

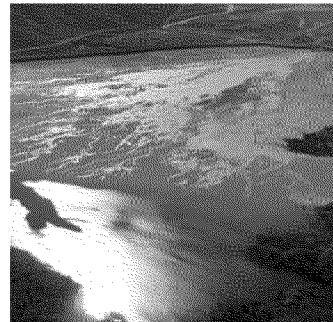
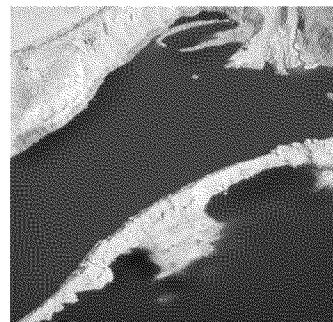
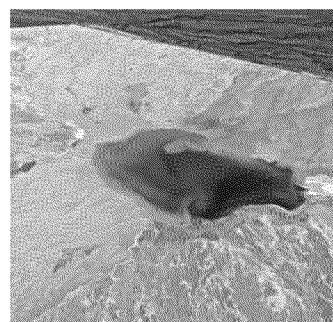
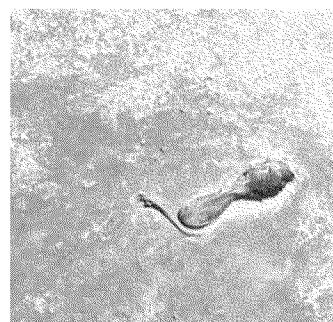
Photos, top to bottom:

Yankee Doodle tailings pond by Ecoflight
Chino Mine by Gila Resource Information Project (GRIP)
Sierrita Mine by Ecoflight
Bird fatality at Tyrone Mine by Jim Kuipers
